# Classification, Effects, and Prevention of Build Defects in Powder-bed Fusion Printed Inconel 718

Prepared By: Arthur Brown

NASA

Marshall Space Flight Center

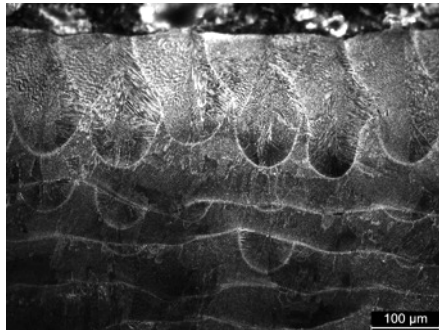
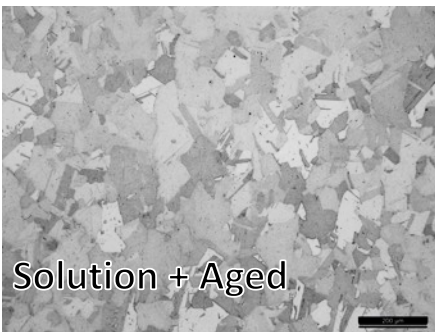
MSFC M1

- As-built microstructures are dominated by the characteristics of the melt pool, which vary based on build parameters.
- Following heat treatment, the microstructure recrystallizes and resembles the wrought microstructure, with some expected grain size variation. IN718 derives strength properties from precipitates in the nickel matrix, which are produced during the solution and aging heat treatments.

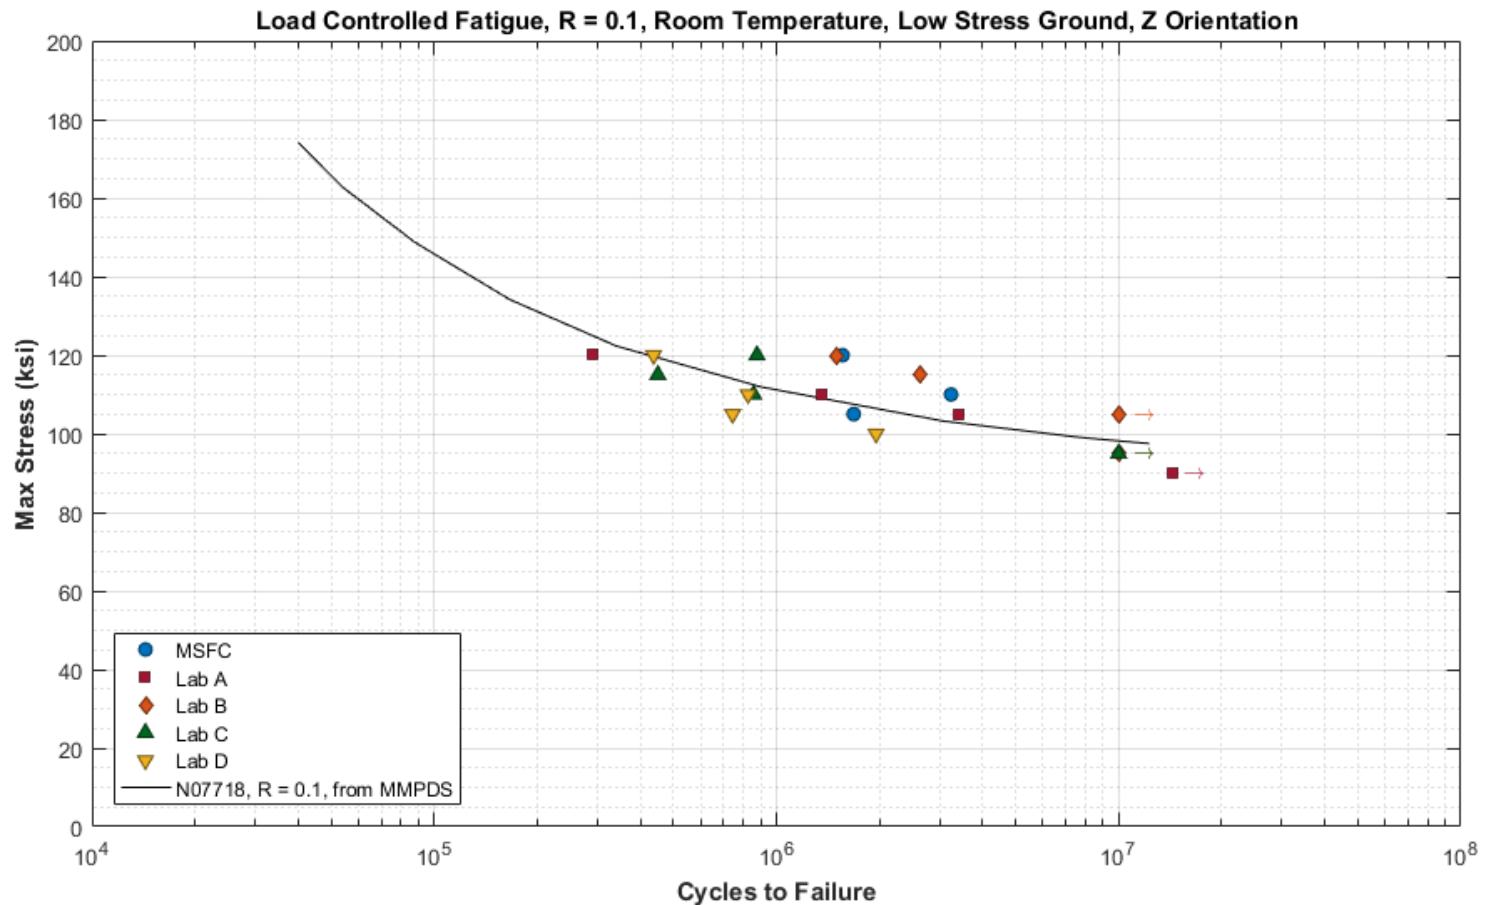
- High cycle fatigue tests align well with an IN718 fatigue reference curve from MMPDS.
- Cycles to failure at a particular stress trended along with ultimate tensile strength, as expected.
